Opportunities and Constraints Detail: Cascade Overlook

Safe Routes To School Analysis: Overview

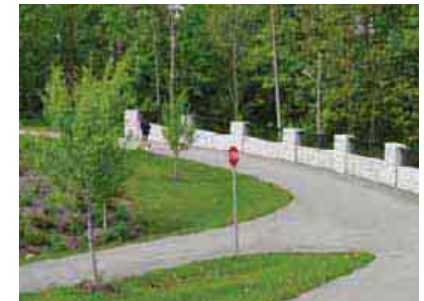
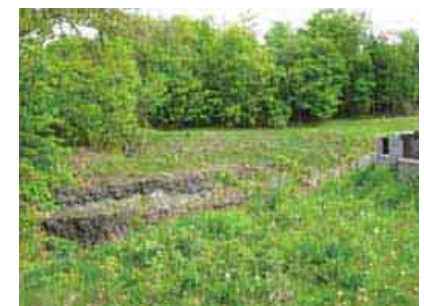
The scenic cascade is not visible from the bike trail

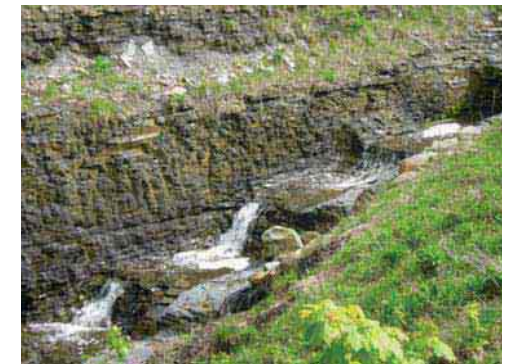
Potential view of the cascade from an overlook

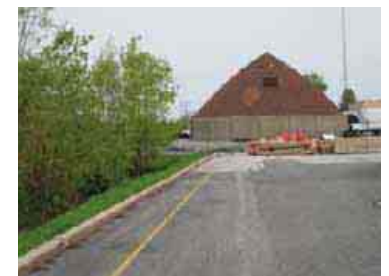
Grade transitions will be difficult for trail passage

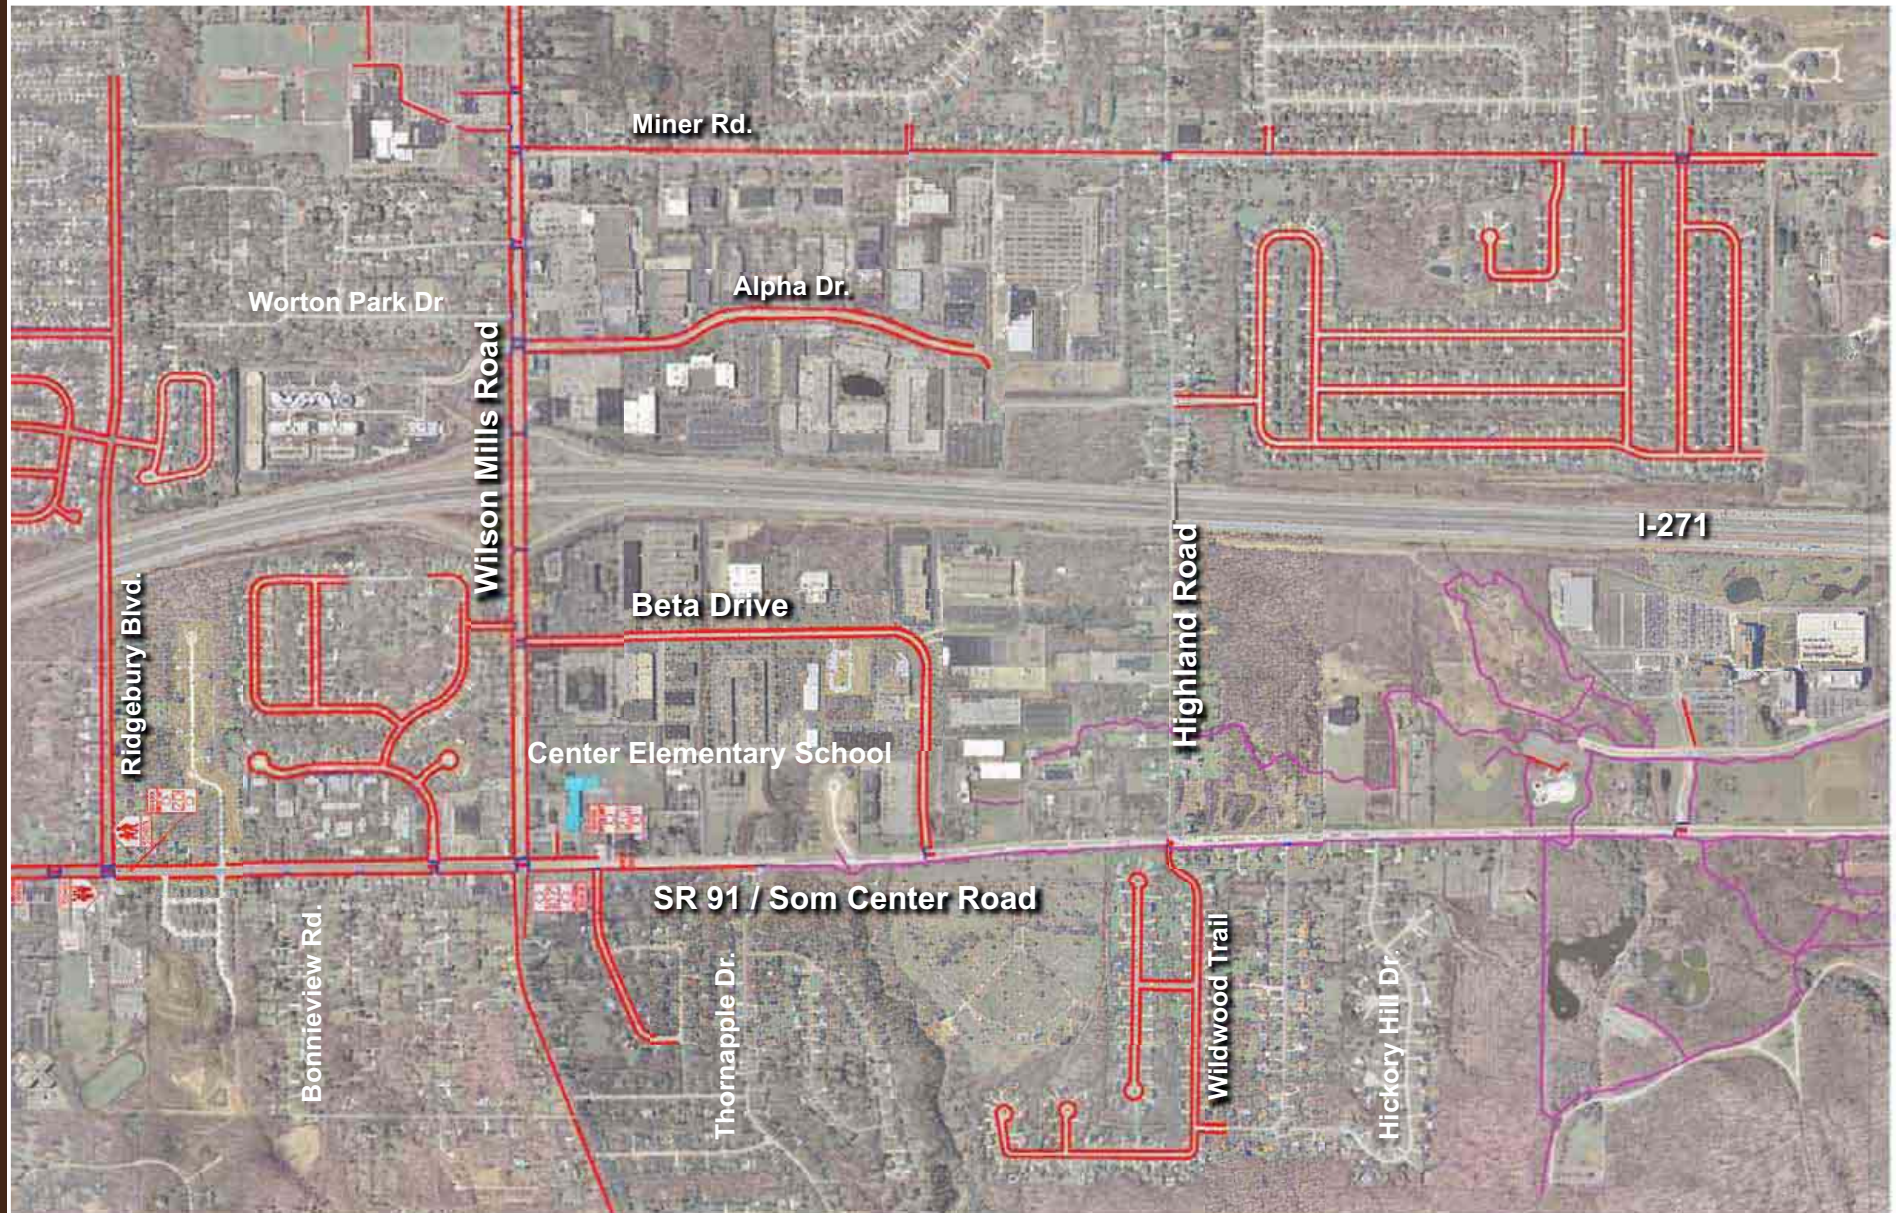
Safe Routes to School Existing Facilities Plan

- Existing Sidewalk
- Existing Bikepath / Trail
- Existing Crosswalks

The existing student walking conditions to reach Center Elementary School are:

- The majority of neighborhoods having sidewalks on both sides
- The exceptions (Hickory Hill, most of Thornapple Drive/Meadowood Dr., Glenview Rd/Bonnieview Rd, and Worton Park Dr/Joyce Rd) are low volume streets with minimal traffic especially during the hours of student commute.
- All students must cross or travel along at least one major roadway to get to school
- Existing underpasses at SOM Center Road provide safe crossing for students, but once across there is no trail system to reach the school

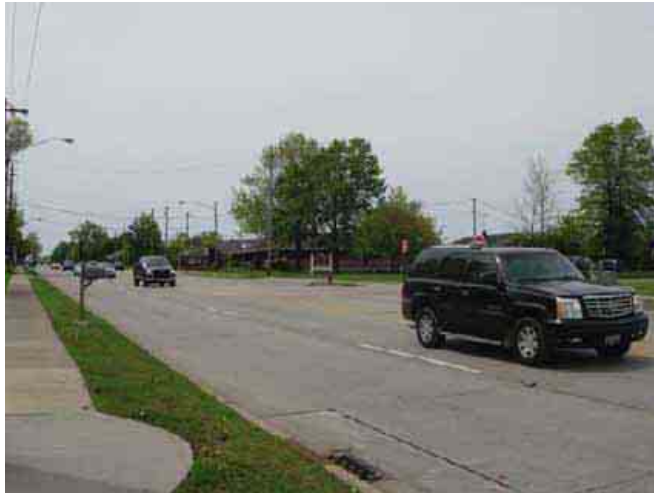
Looking north along SOM Center Rd. 4 lanes of traffic

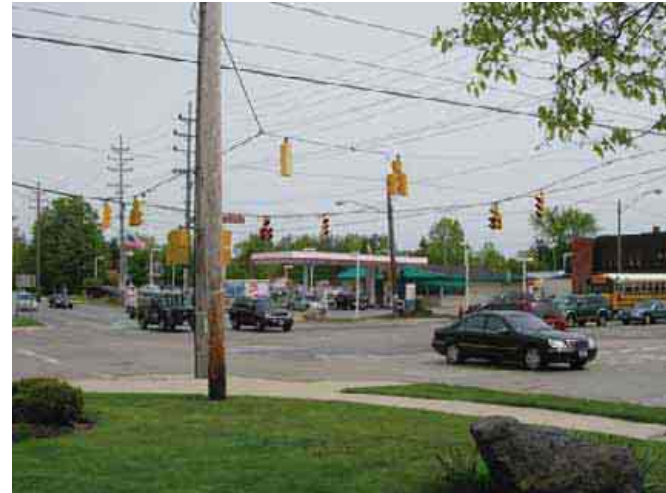
Wilson Mills, SOM Center Intersection, high traffic concentration

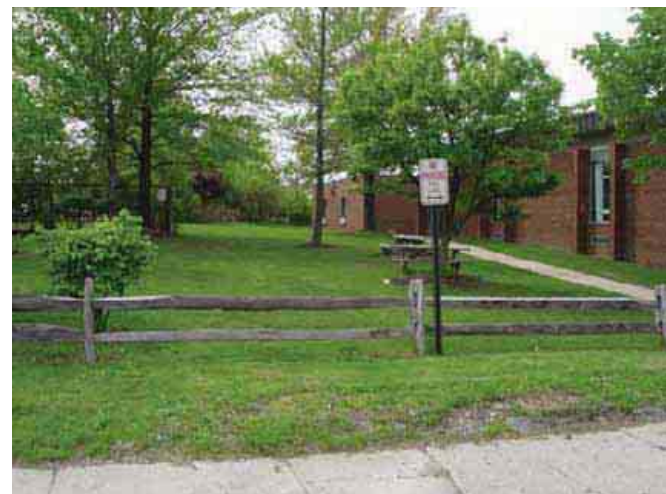
Potential trail pathway to school

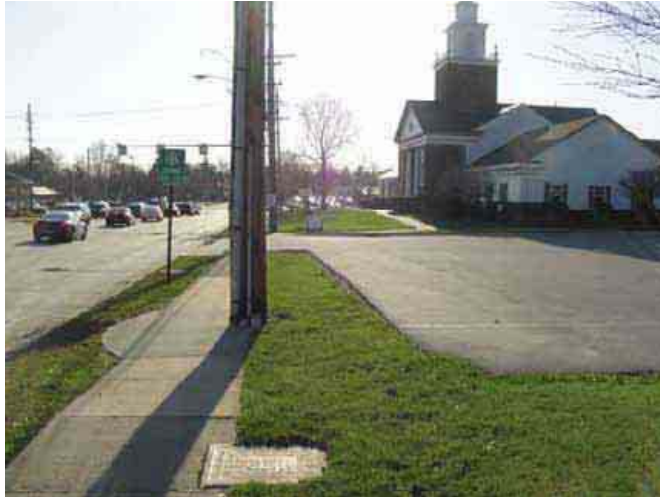
High visibility location for innovative Green Design at the Civic Center

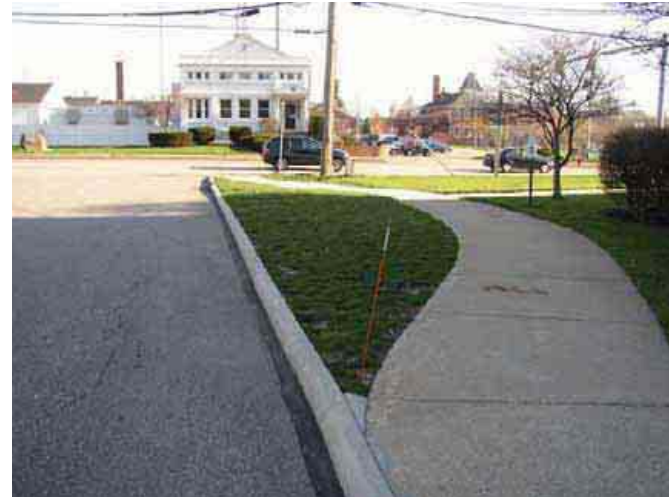
Raingarden opportunity location utilizing existing lawn in front of the Civic Center

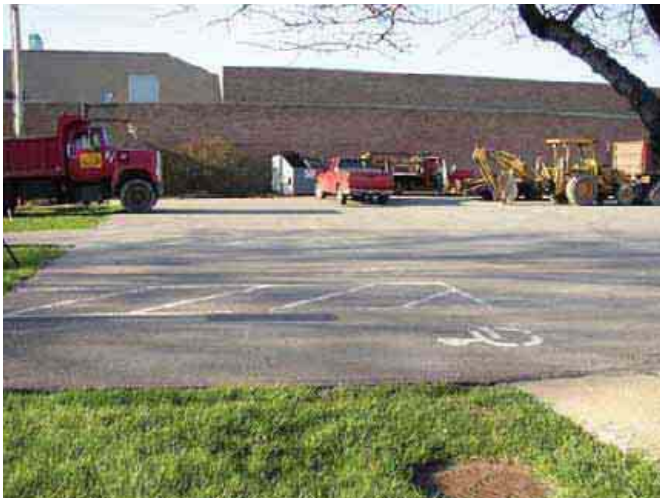
Existing parking lot slopes to lawn areas with existing catchbasin could be utilized for raingardens

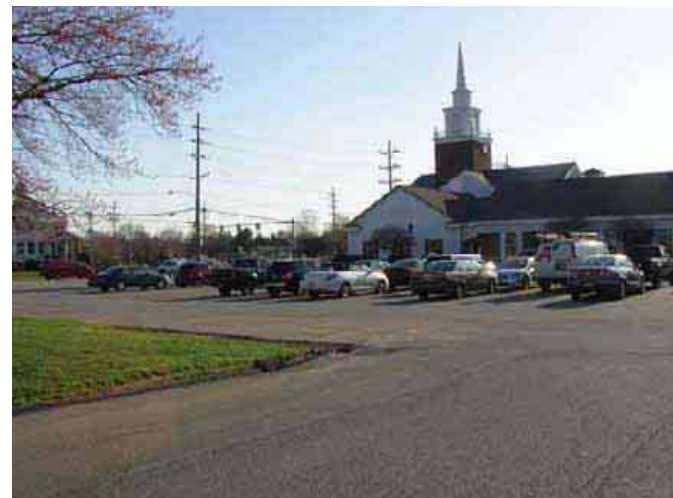
A few parking spaces could potentially be removed for a parking lot raingarden

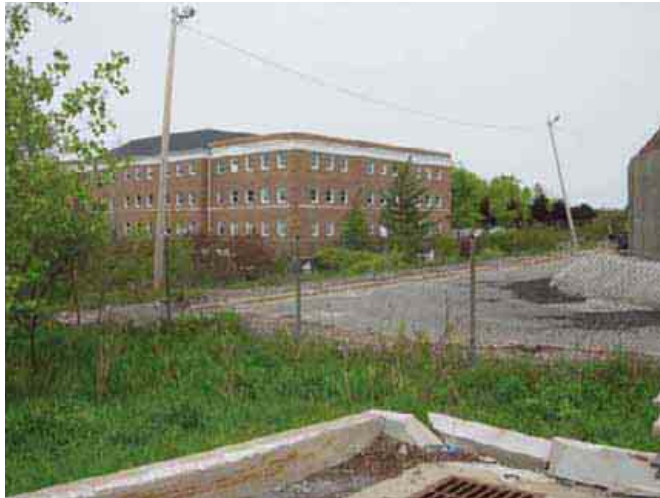
Corner of ODOT property with fence, possible trail location

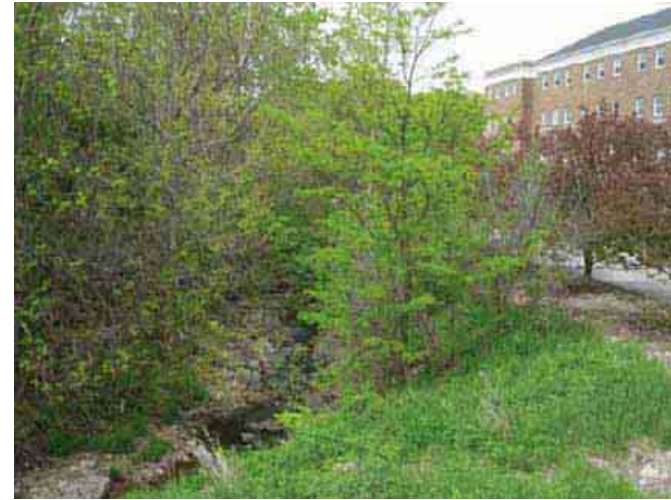
Beechers Brook from corner of ODOT property, steep grade

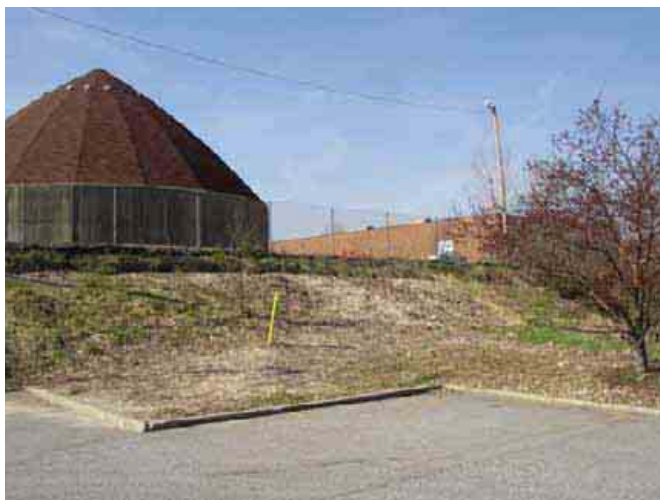
ODOT property displaying difficult grades

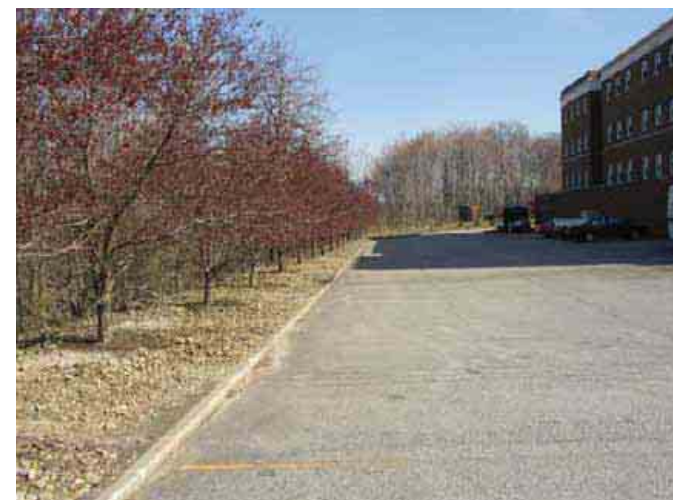
Opportunity for utilizing existing asphalt parking lot for trail

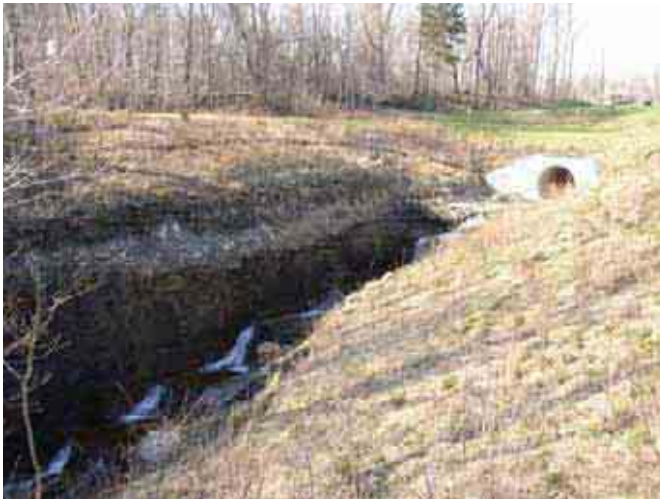
Opportunity for overlook to take advantage of scenic cascade

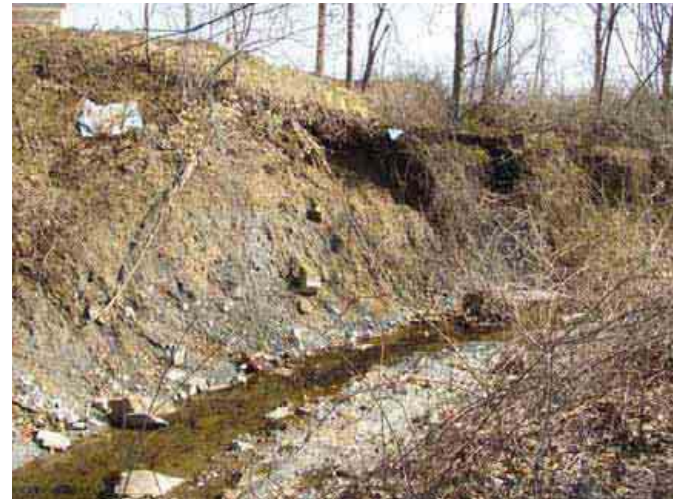
Existing stream erosion zones are stream restoration opportunities

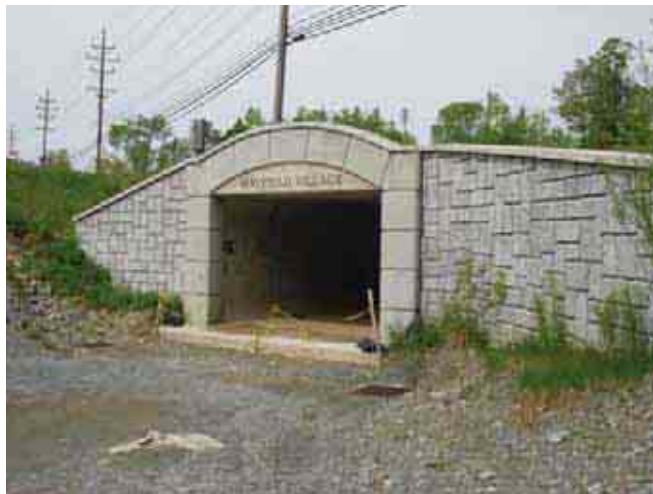
Existing SOM Center Rd. underpass

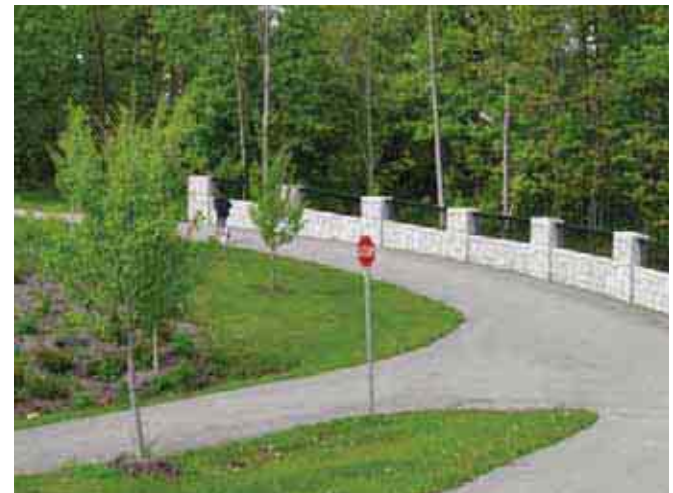
Existing asphalt trail and decorative wall along Cascade

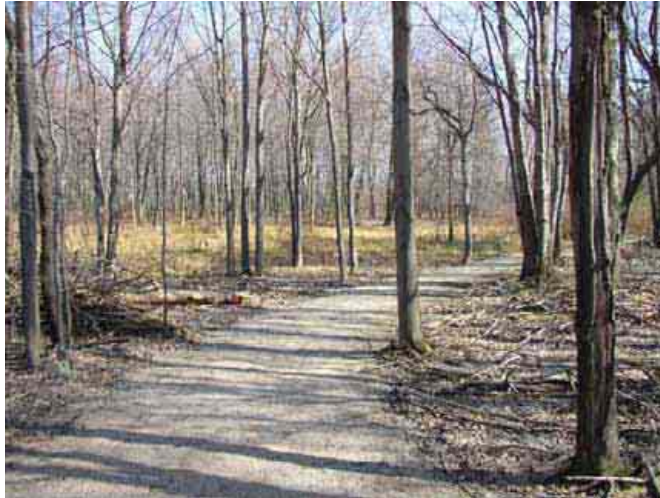
Existing gravel walking path

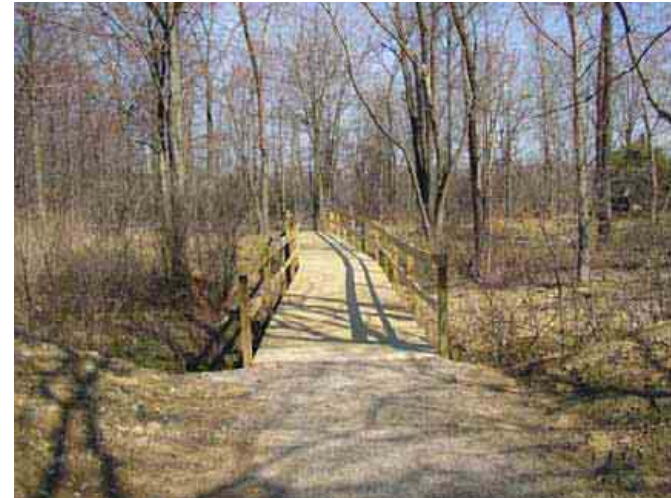
Existing boardwalk

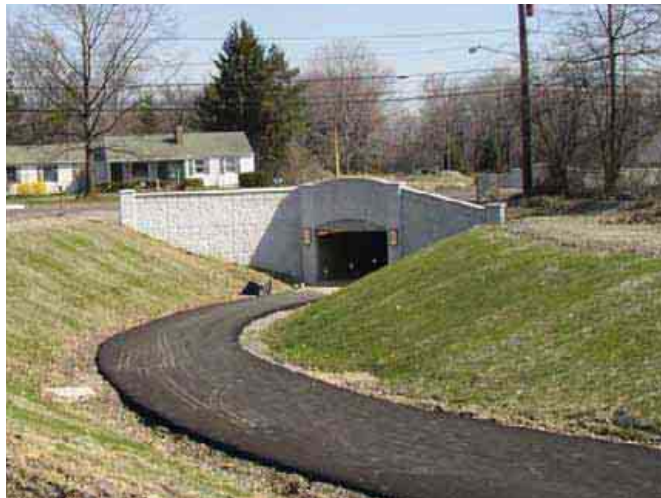
Existing multi-purpose trail leading to underpass crossing Highland Rd.

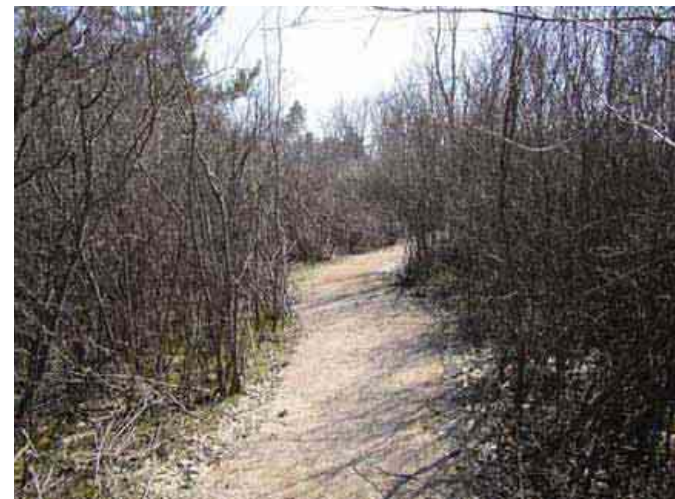
Existing walking trail through a natural setting
